Accelerating Roundabout Implementation in the United States – Volume I of VII

Evaluation of Rectangular Rapid-Flashing Beacons (RRFB) at Multilane Roundabouts

PUBLICATION NO. FHWA-SA-15-069

SEPTEMBER 2015

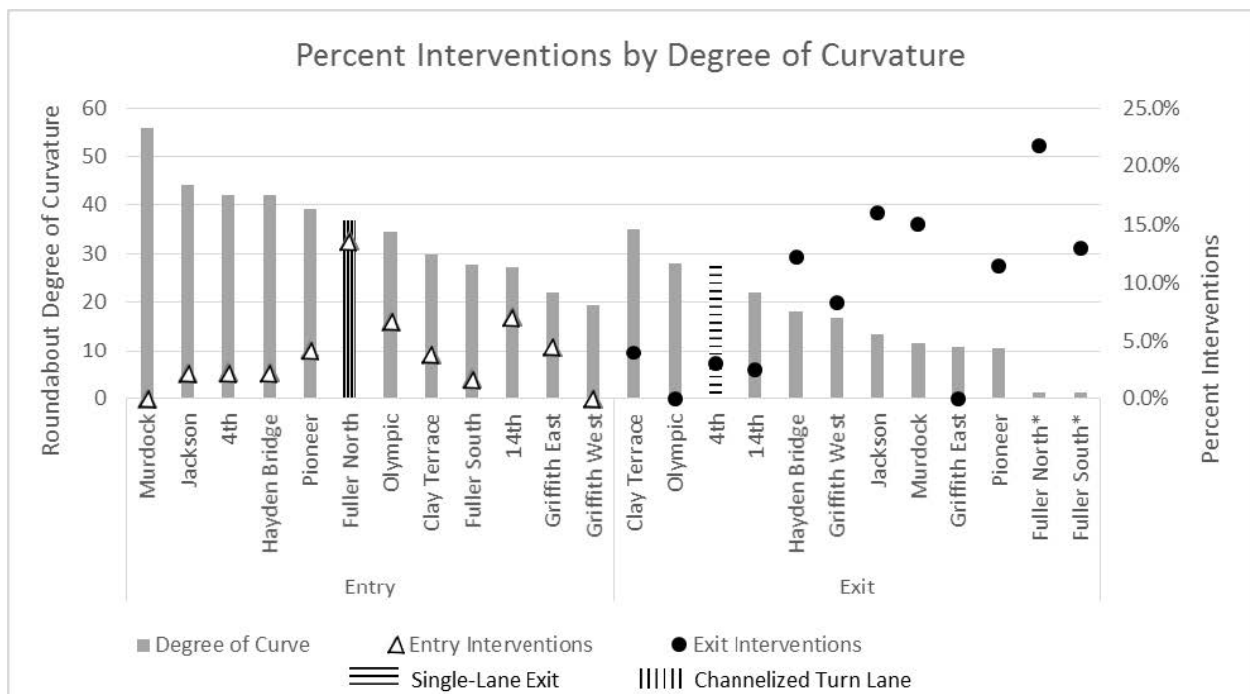
Figure 3. Chart. Percent of interventions as a function of degree of curvature at crosswalk.

A key exception to this trend appears to be the Davidson, North Carolina, roundabout. The site has a relatively large radius exit of more than 152 m (500 ft) at the Griffith East exit, which had zero interventions. Closer evaluation of the site showed relatively low vehicle speeds at that exit, despite the high radius, likely because drivers using this exit transition into a small town and pedestrian-focused environment, and because a second roundabout lies a few hundred feet downstream. In addition, drivers approaching from the west have a good view of the entire roundabout and the crosswalks (and RRFBs) on the east leg. The observation was similar for the west entry at this same roundabout, which also had zero interventions, despite having the largest entry radius studied. This entry is along the same travel path at the east exit. Interestingly, the reverse direction (east entry and west exit) had more interventions despite having smaller radii. Driver perception and expectation may again be a contributing factor here, with drivers leaving the small town community (and the expectation of pedestrian traffic), while accelerating toward a freeway interchange just west of the studied roundabout. This suggests that while geometric characteristics appear to show an effect, local context, driver culture, and visibility of the crossing appear to be equally (if not more) important for pedestrian safety and accessibility of a site.

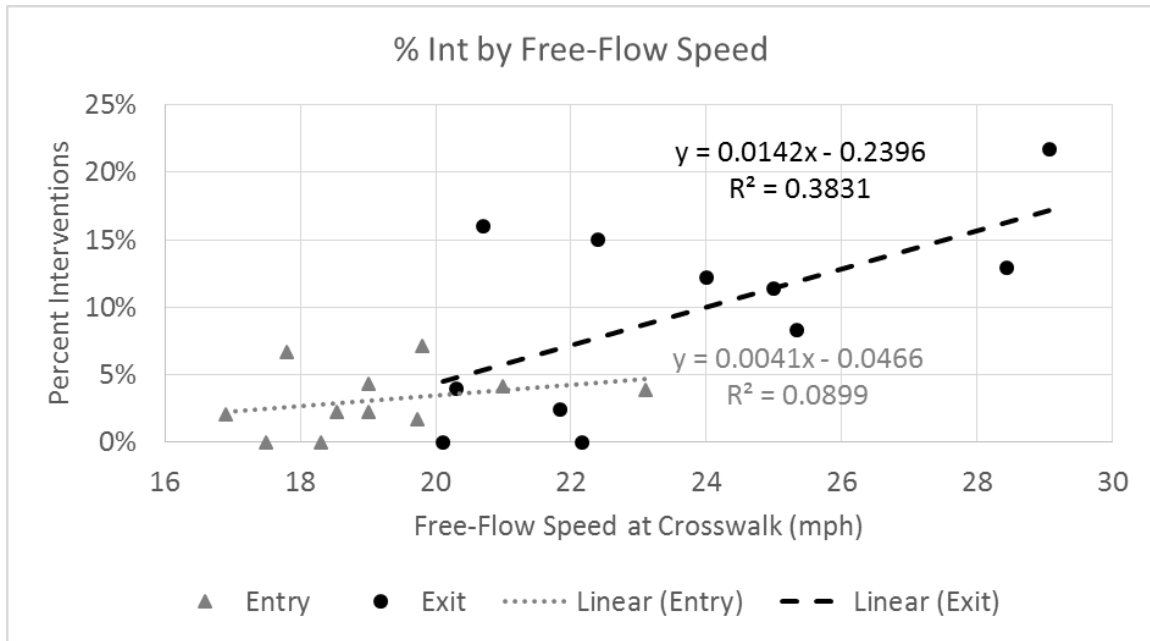
Figure 8 shows the percentage of interventions as a function of free-flow speed measured at the crosswalk (sample of 30 free-flowing vehicles without pedestrian presence). The chart shows entry legs in gray triangles and exit legs in black circles. The channelized turn lane at entry and the single-lane exit were excluded from this analysis.

Figure 8. Graph. Percent intervention as a function of free flow speed at crosswalk.

According to the data presented in figure 8, there is a positive correlation between percent intervention and speed for exits, and suggests a weak positive relationship for entries. Exit speeds and percent interventions are generally higher than entry speeds and percent interventions. Figure 8 also shows that the effect of speed (slope of the line) on percent intervention is more than three times as large for exits, suggesting that exit interventions are more sensitive to speed than entry interventions. The R-squared values for entry and exit are 0.0899 and 0.3831, respectively, indicating a stronger correlation at exit than entry.

The observed percent intervention behavior is different below about 35 km/h (22 mph) than it is above that speed. For sites with free-flow speed below this threshold, all but one location exhibited less than 10 percent interventions, and 12 out of 14 had less than five percent interventions. For sites with a free-flow speed greater than 35 km/h (22 mph), five out of seven had more than 10 percent interventions, and six out of seven had more than five percent interventions. This finding does not imply that all crosswalks with free-flow vehicular speeds greater than 35 km/h (22 mph) are inaccessible, nor that all crosswalks with free-flow speeds less than this value are accessible. Other research⁽¹²⁾ suggests that in some cases factors such as ambient noise and the visibility of pedestrians, the crosswalk, and associated signs and markings may have a greater influence than vehicular path radii and free-flow speeds. Nonetheless, it appears designs with free-flow exit speeds greater than 35 km/h (22 mph) have a higher likelihood of being inaccessible than those with lower vehicular path radii and free-flow speeds.

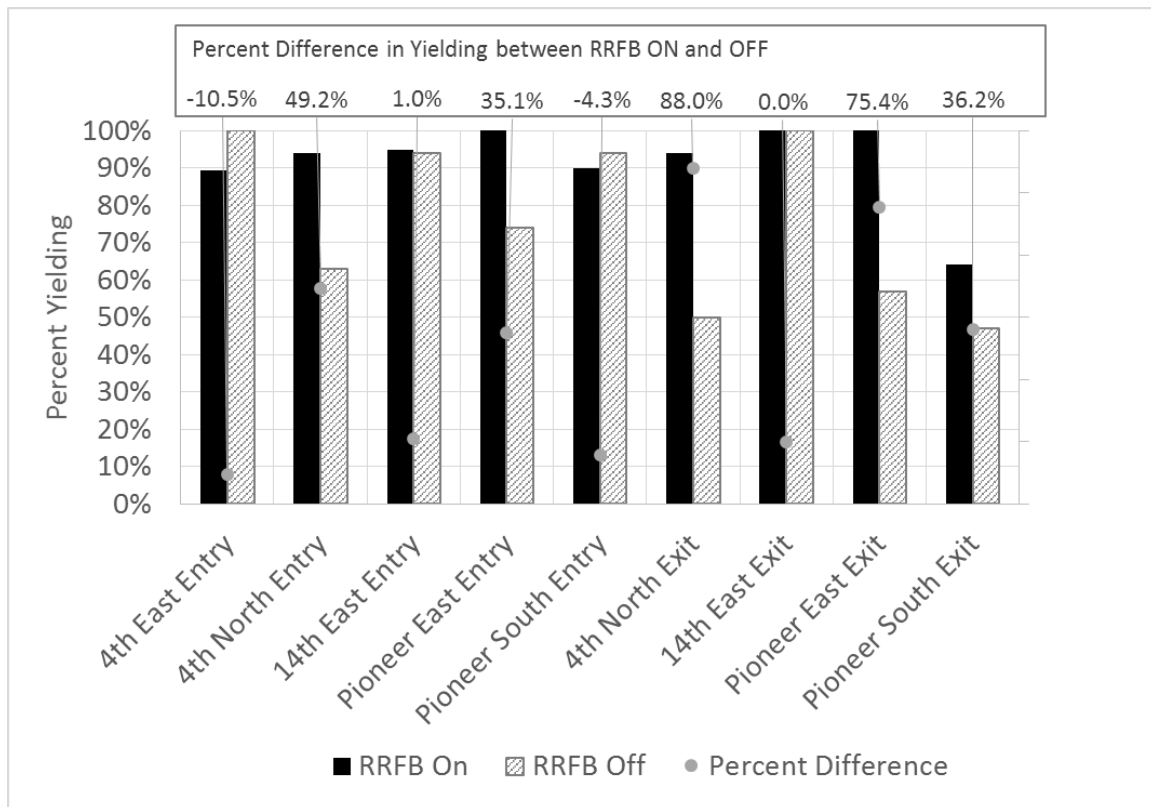
The RRFB was always activated in trials measuring percent intervention. However, at nine approaches, the team performed the naturalistic yielding study both with and without the RRFB devices activated to compare yielding behavior between those conditions. The results are shown in figure 13.

Figure 13. Chart. Effect of RRFB activation on yielding.

where yield rates were compared between RRFB conditions had yielding rates below 45 percent, so these results should not be extrapolated to sites with lower non-RRFB yielding rates.

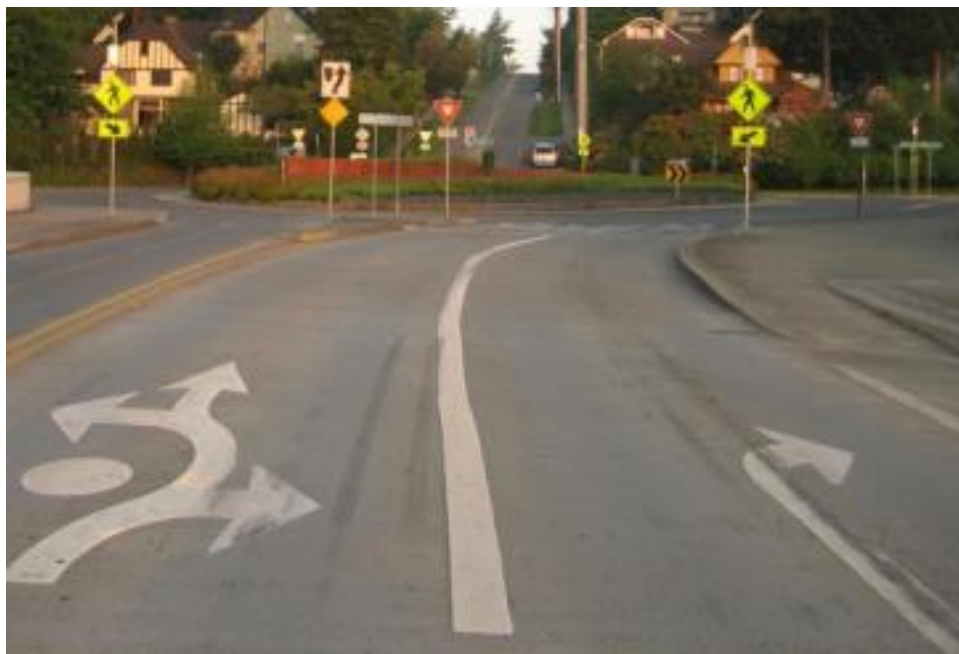
Figure 16. Photo. 4th Ave. W, east leg two-lane entry, one-lane exit, Olympia WA.

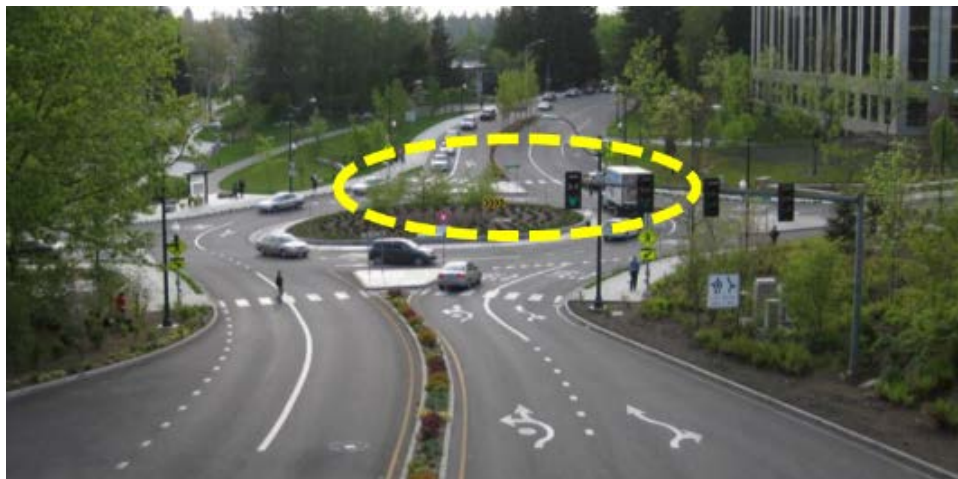
Figure 19: Photo. Phase I data collection site, Jefferson St. at 14th Ave. SE, Olympia WA.

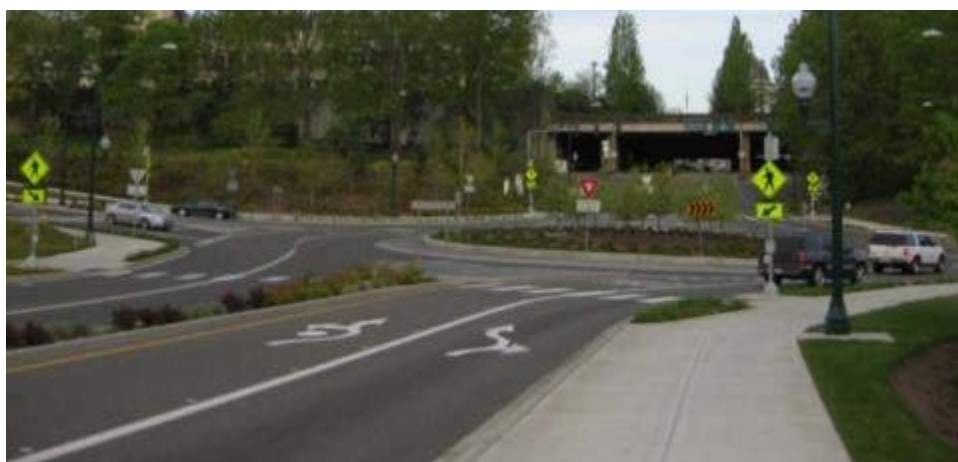
Figure 20. Photo. 14th Ave SE, east leg two-lane entry, two-lane exit, Olympia WA.

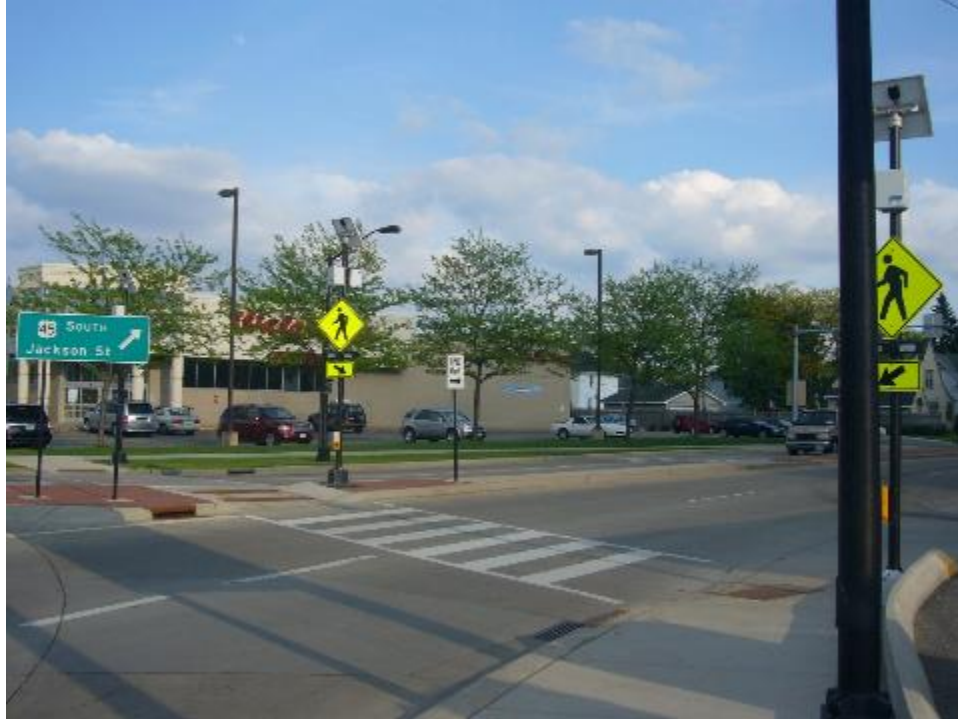
Figure 25. Photo. Street-level view of Southern Approach on Jackson Street., Oshkosh, WI.

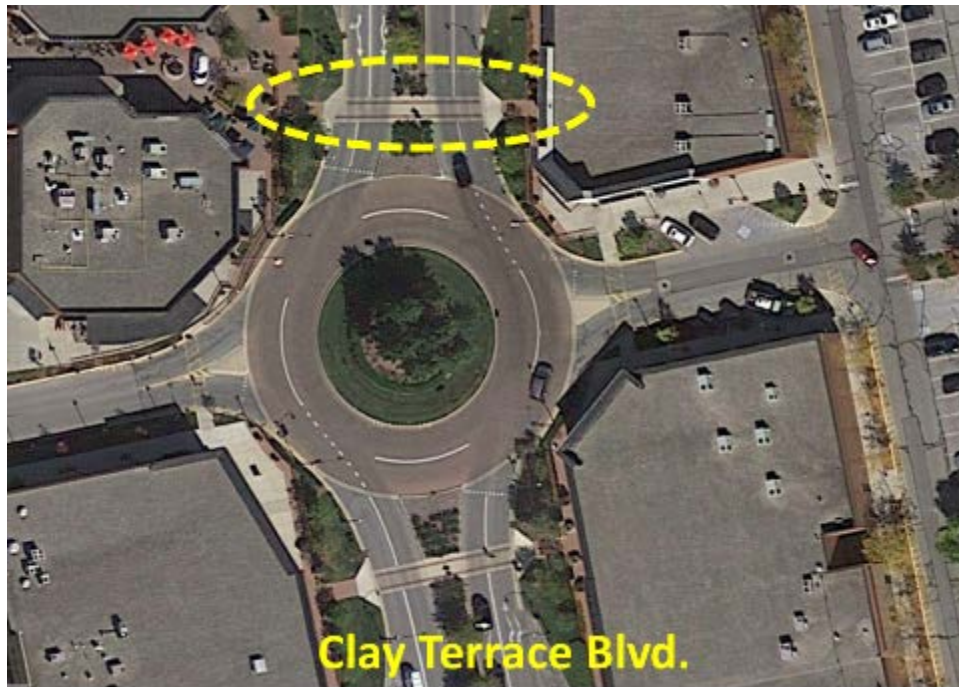
Figure 26 shows an aerial photo of the data collection site located in Carmel, IN, in the Clay Terrace shopping center. Only the north east approach of the roundabout was equipped with RRFB and therefore that approach was the only one studied. Figure 27 and figure 28 show street-level views of the studied crosswalk and approach to the roundabout.

Figure 26. Photo. Phase II data collection site, Clay Terrace Blvd., Carmel, IN.

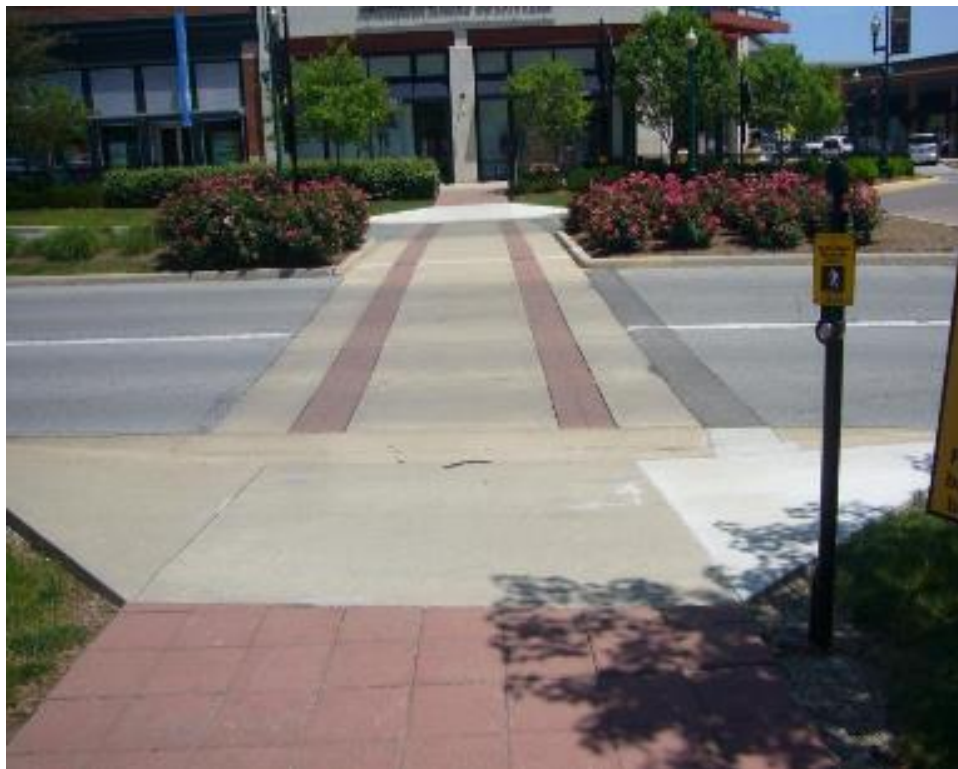
Figure 27. Photo. Street-level view of the studied crosswalk on Clay Terrace Blvd., Carmel, IN.

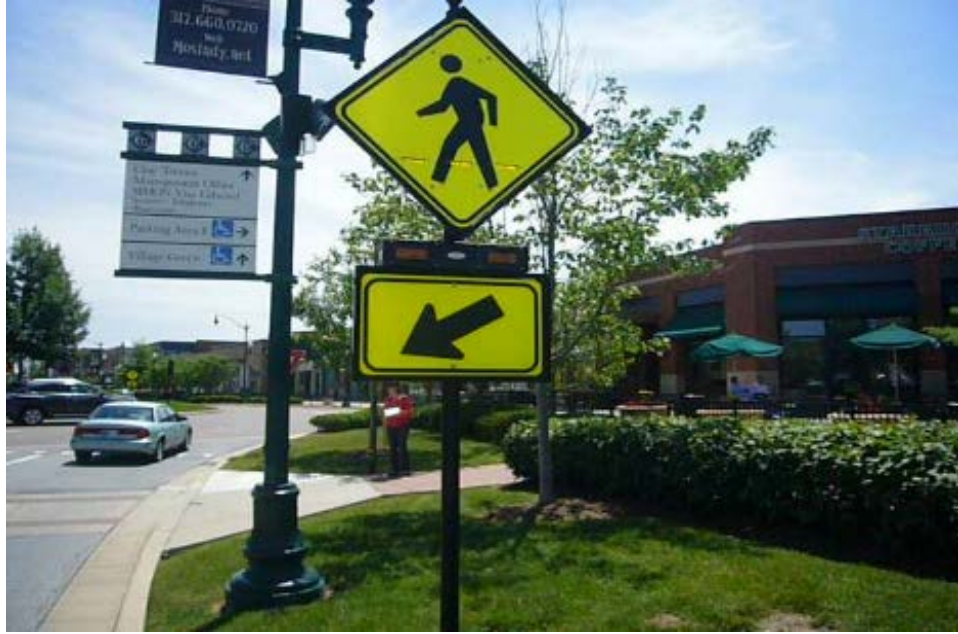
Figure 28. Photo. Street-level view of approach on Clay Terrace Blvd., Carmel, IN.

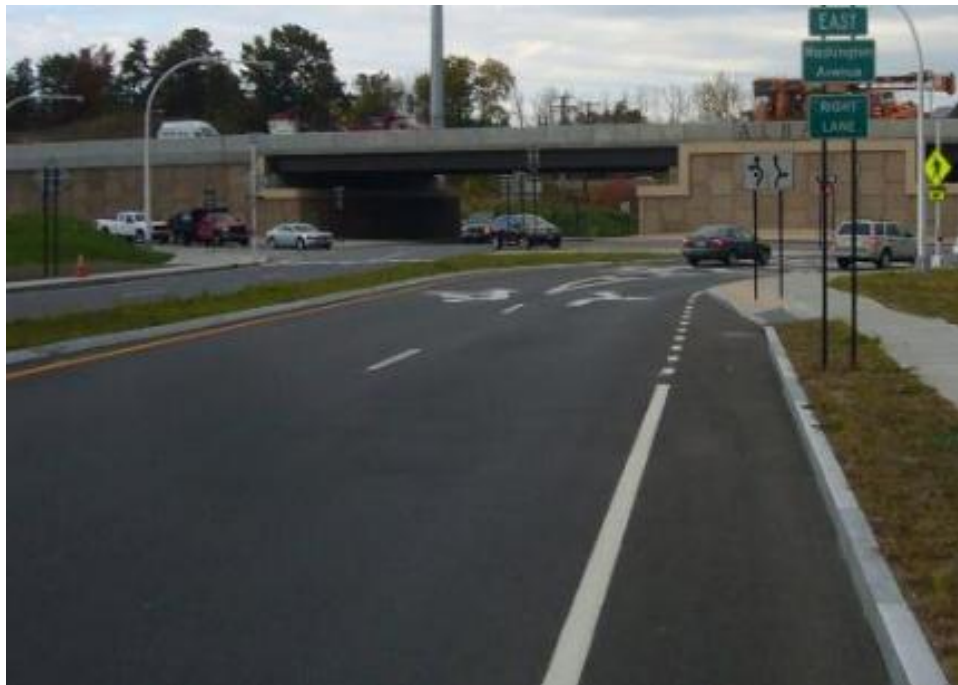
Figure 30. Photo. Street-level view of southern approach on Fuller Rd., Albany, NY.

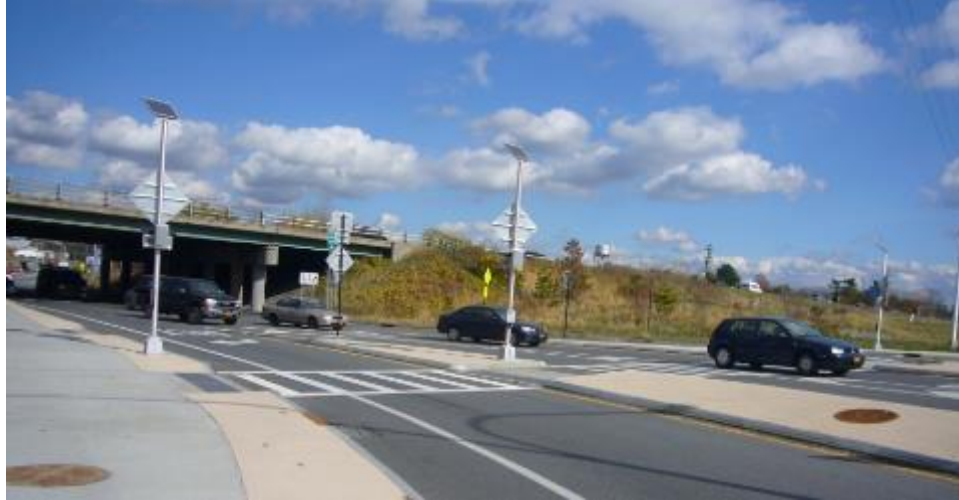
Figure 31. Photo. Street-level view of channelized turn lane on northern approach on Fuller Rd., Albany, NY.

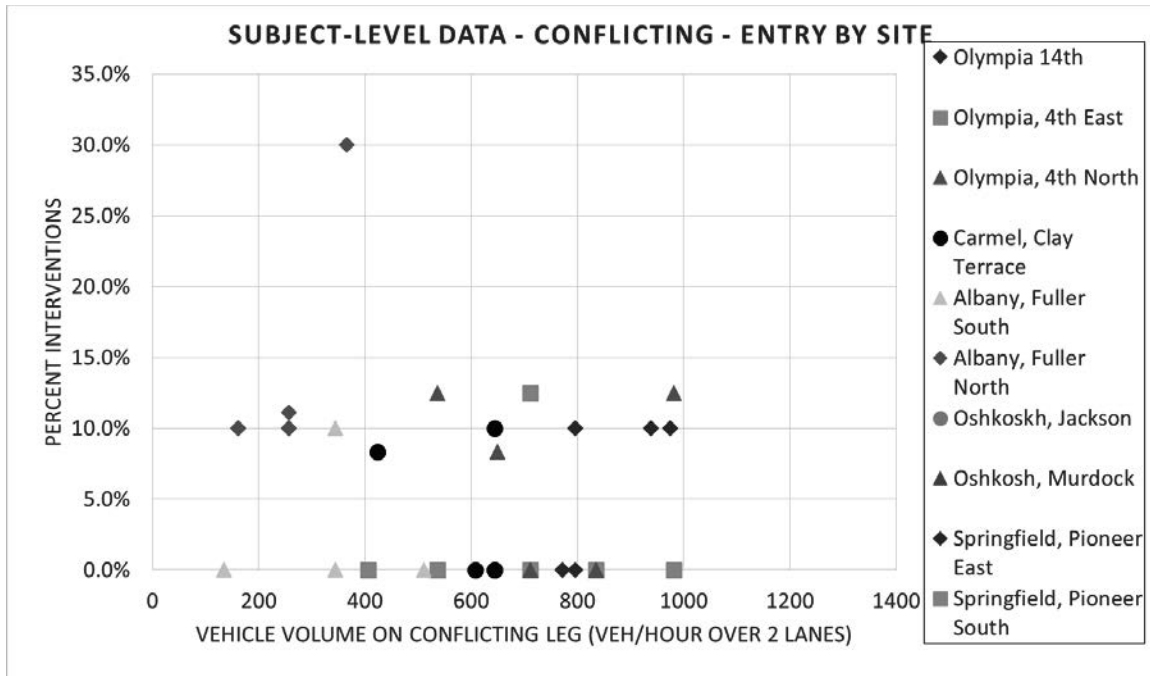
This section is an evaluation of percent interventions as a function of traffic volume on the lanes closest to the participant based on the individual subject-level data divided by site.

Figure 39. Plot. Percent intervention as a function of vehicle volume for individual sites- entry.

Figure 39 shows there are no clear patterns evident from the data. The following are the noteworthy observations for each site. 14th Ave. in Olympia, WA, generally had high volumes with a mix of interventions (0% to 10%). 4th St. East in Olympia, WA, had mid to high volume with generally zero interventions, except for one participant (13%). 4th St. North in Olympia, WA, had mid to high volumes with a mix of interventions (0% to 12%). Clay Terrace Blvd. in Carmel, IN, had mid to low volumes with a mix of interventions (0% to 10%). South Fuller St. in Albany, NY, had mid to low volumes with a mix of interventions (0% to 10%). North Fuller St. in Albany, NY (channelized turn lane) had relatively low volumes with high interventions (10% to 30%). Jackson St. in Oshkosh, WI, had mid-level volumes with mostly zero interventions, except for one participant (10%). Murdock Ave. in Oshkosh, WI, had mid-level volumes with all zero interventions. Hayden Bridge Rd. East in Springfield, OR, has mid to low volumes with generally zero interventions, except for one participant (10%). Pioneer Pkwy. South in Springfield, OR, has mid to low volumes with a mix of interventions (0% to 10%).

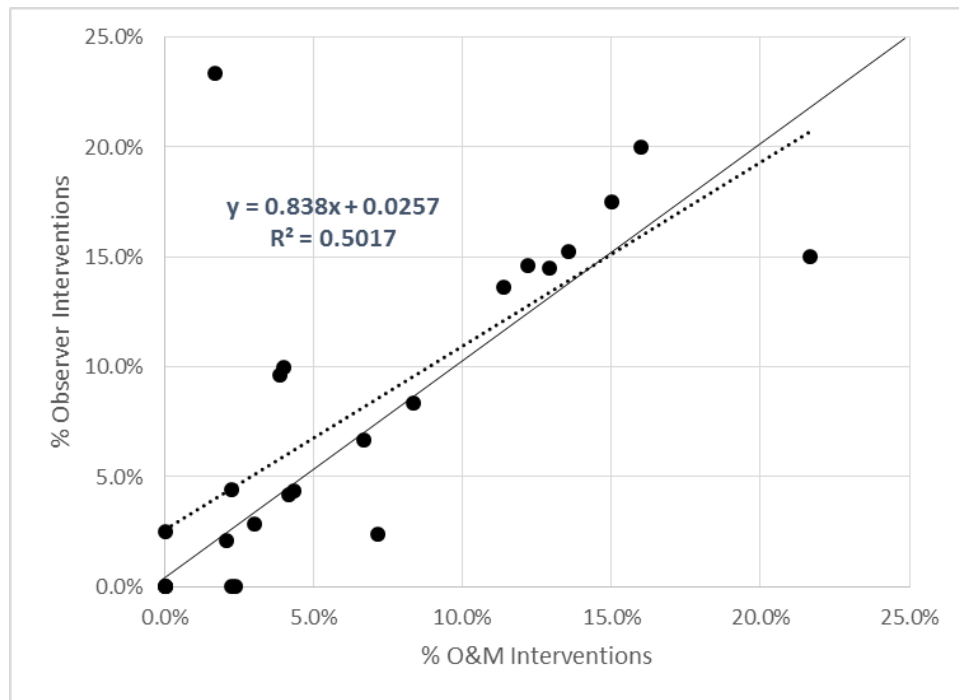
line is shown in the graph. This trend is influenced greatly by the Albany, NY, outlier site. Without those outliers, the two ratings have a level of agreement above 80 percent.

Figure 42. Graph. Comparison of observer and COMS percent interventions.
